TP 185E
Issue 3/2006

AVIATION SAFETY LETTER

Recently Released TSB Reports

Accident Synopses

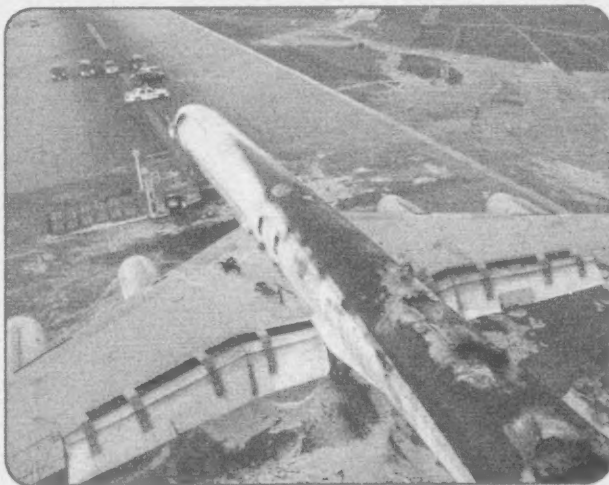
Hot Cargo?

This courier flight made an emergency landing in Philadelphia, PA, after the crew detected smoke in the cockpit. The SMOKE/FIRE warning light illuminated three minutes prior to landing, and the crew asked the tower controller to confirm the presence of fire trucks, which the controller did. Upon landing, the airplane was immediately engulfed in fire and the three members of the crew evacuated the airplane via the cockpit window and a door slide. The crew was not injured; however, the airplane was destroyed. The crew did a brilliant, by-the-book job of saving their own lives, while the professional response from ATC and the firefighting units also contributed to their timely and successful egress. Two known pieces of hazardous materials (HAZMAT) were reportedly on board: amyl methyl ketone and tire repair kits. Δ

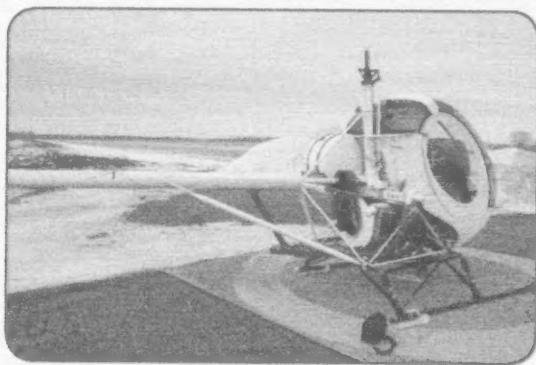
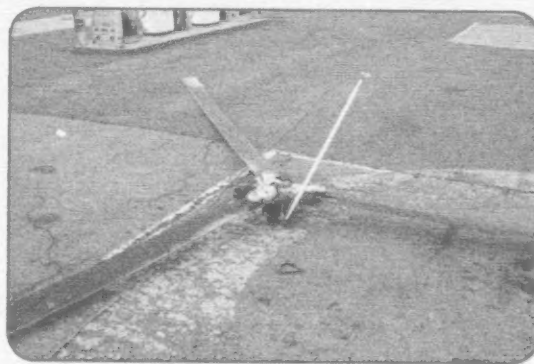
TSB Final Report A04Q0026— Separation of Main Rotor on Run-up

1. The input quill bearing housing was not positioned in accordance with the procedures described by the manufacturer; therefore, the flow of oil was obstructed, causing the catastrophic failure of the input quill bearings.
2. Independent inspection did not detect the incorrect reassembly of the main transmission gearbox.

1. There are no mechanical means to prevent an installation error when installing the input quill bearing housing.
2. The force required to shear the main rotor shaft is higher than the force required to shear the six rotor head attachment bolts. As a result, the rotor could separate from the shaft in the event of a sudden stoppage of the transmission, which constitutes a hazard for helicopter occupants and people on the ground.

Main rotor lays on the ground, after it separated from the aircraft

At the completion of the main transmission overhauls, at sudden stoppage inspections, or in any other situations in which the retainer has to be removed, the overhaul company will paint a red witness line on the retainer and on the transmission housing to assure alignment of oil ports. Also, they will run the transmission for 15 min to check that there is oil flow in the transmission, and to check for oil leaks at the seal and split line. These changes will be put into their worksheets.

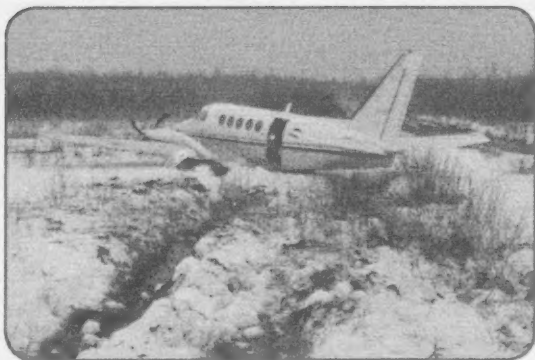
TSB Final Report A04Q0049— Runway Excursion

1. The aircraft was positioned over the runway threshold at an altitude that did not allow a landing at the beginning of the runway, and this, combined with a tailwind component and the wet runway surface, resulted in a runway excursion.
2. Failure to follow standard operating procedures (SOP) and a lack of crew coordination contributed to confusion on landing, which prevented the crew from aborting the landing and executing a missed approach.
3. The pilot-in-command held several management positions within the company and controlled the pilot hiring and dismissal policies. This situation, combined with the level of experience of the co-pilot compared with that of the pilot-in-command, had an impact on crew cohesiveness.

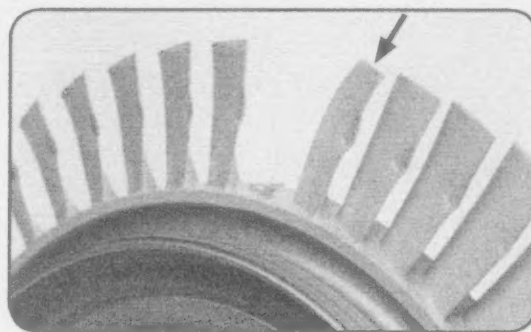
Arrow pointing to blade failure caused by thermally-induced fatigue cracking

1. Thermally-induced fatigue cracking initiated radially inward in a low-cycle mode in the blade platform fillet area, then progressed normal to the blade axis in a high-cycle mode, eventually resulting in a blade failure due to overstress rupture when the remaining area could no longer support the applied loads.

1. Hot starting events and/or power transients are not recorded in this type of helicopter and may not be recorded accurately by an operator even if detected. Turbine wheel failures may occur when hot starts and power transients are undetected, or if their effects go unchecked.
2. The first-stage turbine wheel revealed many type A, and approximately four type B, cracks in the blade rim, and cracks in the fillet radius of blades can lead to turbine failures. There is no prescribed scheduled inspection to detect these cracks, but a turbine special inspection is

recommended when turbine outlet temperature limits are exceeded. No cracks in the blades are allowed.

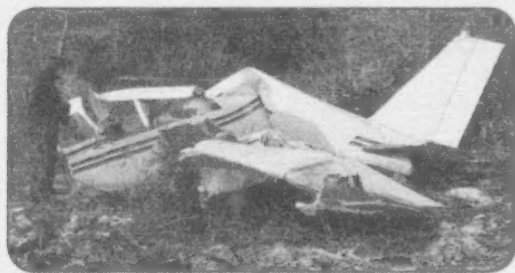
*TSB aircraft accident investigator
Allan Chaulk examines the wreckage*

1. The aircraft was flying in conditions conducive to serious carburetor icing at any engine power setting. It is likely that carburetor ice formed and restricted the engine power available to the point where the aircraft would not maintain level flight.

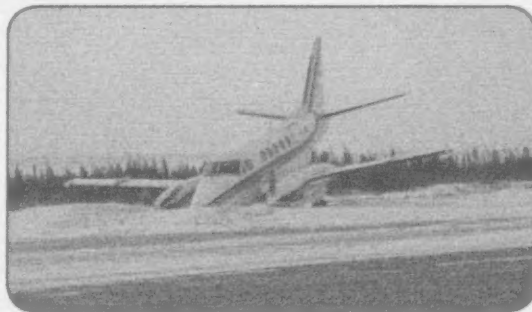
TSB Final Report A04Q0199— Runway Excursion

1. The crew did not assimilate the information regarding wind and runway conditions, and continued an approach for which there was no viable landing option.
2. The first officer did not anticipate a landing on Runway 07, which did not allow the crew to properly discuss the risk of landing on a slippery runway in strong crosswind conditions.
3. The flight crew did not make use of crosswind charts during flight planning or when preparing to land at Kuujuaq.
4. Company SOPs do not provide specific guidance with respect to maximum crosswind or minimum Canadian Runway Friction Index (CRFI) values.

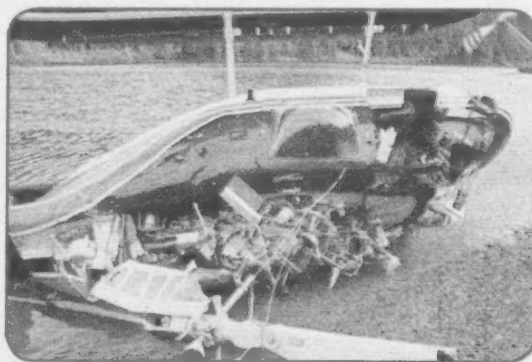
1. Glassy water conditions impaired the pilot's ability to judge his height above the lake, and during the landing, the helicopter's floats contacted the water before the pilot expected them to, dug in, and the helicopter flipped over.
2. One of the helicopter's main-rotor blades broke on contact with the water and penetrated the front of the helicopter. Wreckage debris struck the pilot and the front-seat passenger on their heads.

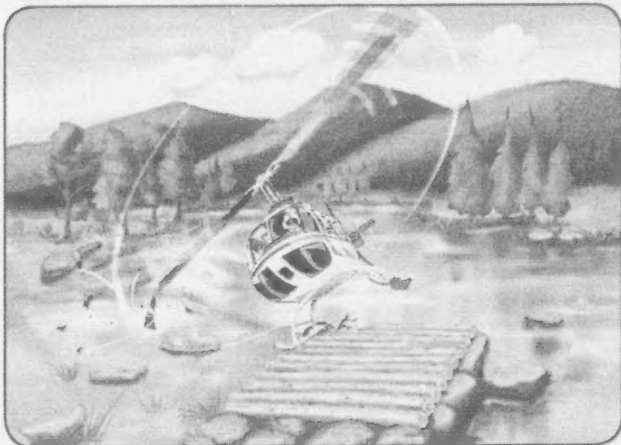
—On November 9, 2005, a Bell 206B helicopter was transporting two passengers from Island Lake, Ont., to a fishing camp situated 50 NM east of Island Lake, on East Lake, Ont. Upon touching down on a log-constructed landing pad, the pilot applied collective to reposition the helicopter on the pad. The right bear paw on the high-skid landing gear caught a root or stump near the pad, and the helicopter rolled over onto its right side. The pilot and passengers were wearing shoulder restraints, which minimized their injuries; one passenger received a minor cut to the head. The pilot used an on-board satellite phone to call for assistance. *TSB File A05C0204.*

Artist's impression of the rollover as it happened

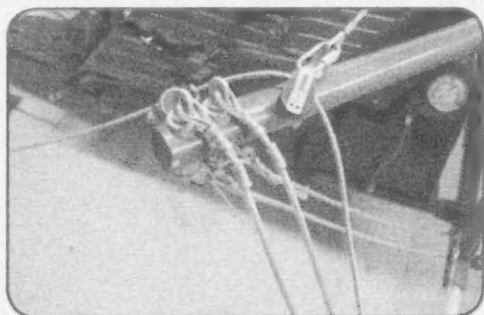
The pilot encountered control difficulties immediately after lift-off, and at that time, it was observed that a stainless steel riser cable was looped around the left outrigger arm. The pilot and passenger attempted to slide the riser cable over the end of the outrigger to remove the loop; however, the cable was taut and could not be repositioned due to the air loads on the canopy. The left turn progressed to a tight left spiral, and the parachute collapsed prior to the cart impacting the ground.

Figure 1. Close-up of left outrigger and eye bolts, with the riser cables in the correct pre-flight position

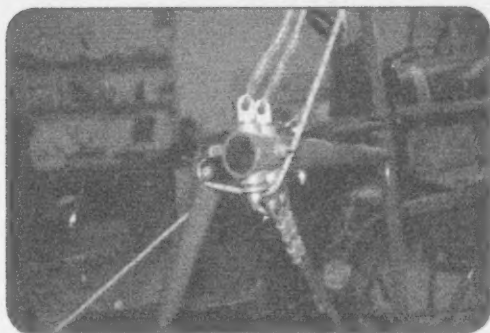
With either system, a pilot must verify that the steering lines, risers, and suspension lines are correctly positioned above the outrigger arms on the pre-flight check, by "walking the lines" with the parachute canopy and suspension lines laid out behind the cart. Standard practice also requires that the pilot apply partial power to get the cart rolling slowly at the beginning of the take-off run, and then conduct a "shoulder check" to the left and right as the parachute rises over the cart, to visually confirm that the steering lines and risers are correctly positioned above the outrigger arms. If a riser or steering line wraps around an outrigger, the wrap will effectively shorten the riser or steering line, which precludes proper chute inflation (see Figures 3 and 4).

Figure 3. Photo of the steering line wrapped around the outrigger, with the riser cables upright in the normal in-flight position

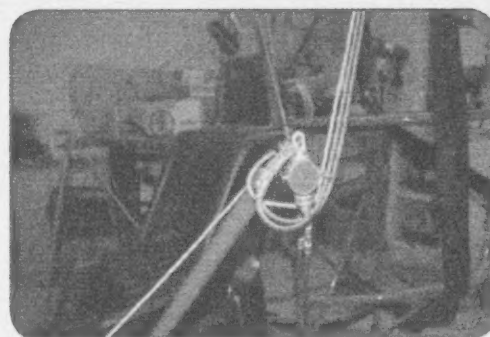
Figure 4. Photo of riser cables and steering line wrapped around the outrigger arm

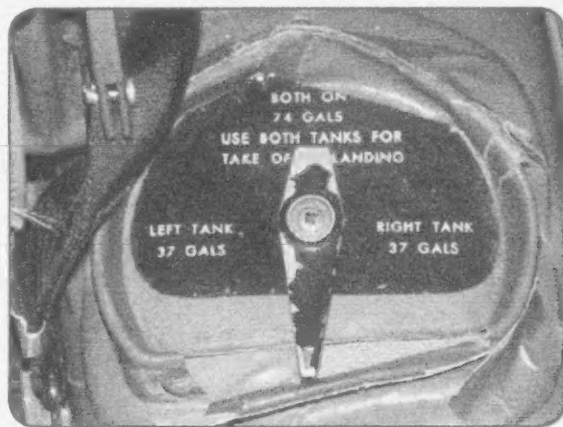
Figure 2. Damaged fuel tank selector cover—fuel selector in undocumented OFF position

As seen in Figure 2, the ridge on the plastic cover was damaged, allowing the selector valve to be rotated to the OFF position. The valve was also partially obscured by the water rudder handle, so the pilot relied on feel to determine the switch position, and the incorrect position of the valve was undetected. The fuel in the accumulator tank (approximately ½ gal.) was sufficient to allow the pilot to start the engine, taxi, carry out run-up and before-takeoff checks, and take off, before it was exhausted, shortly after the aircraft became airborne.
